10 Otis Hotel, 110 S Madison Spokane, WA
11 99201

WISHA SAFETY AND HEALTH
INSPECTION ENTRY WARRANT

COMPLIANCE OFFICER'S
RETURN OF SERVICE

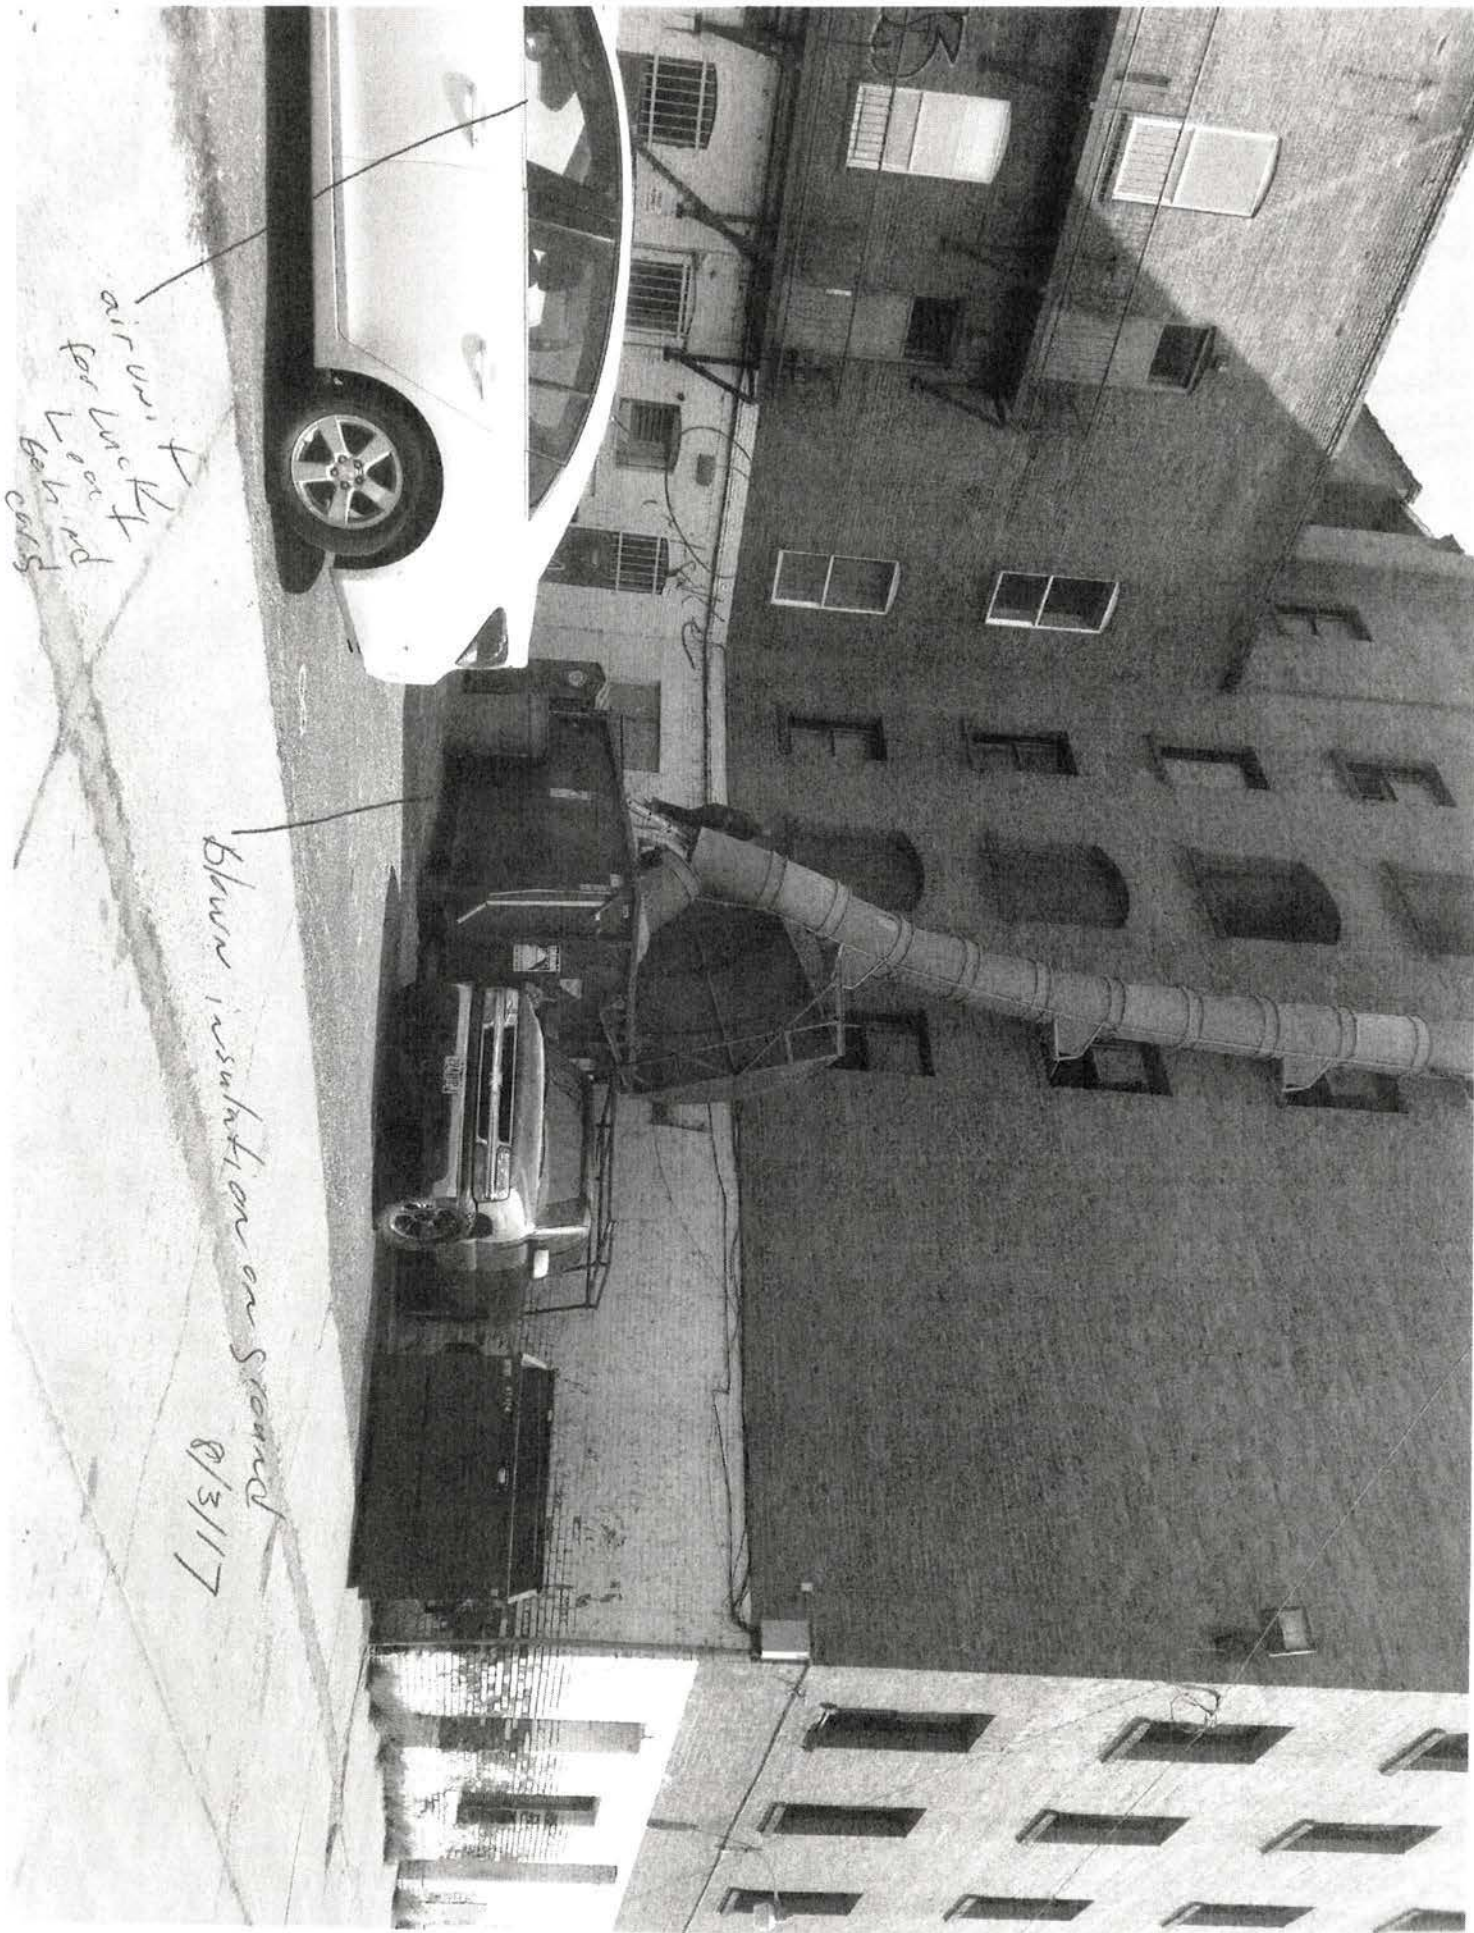
On 8/3/17 at around 10:15am, (b) (6), and I responded to the Otis Hotel for an asbestos related dust complaint. Prior to going out I noticed some issues with NOI#2017-0364 for the Otis Hotel. I spoke with (b) (6) of Native Land Development and determined that she had mistakenly marked hazardous conditions when filing not knowing what it really meant. It was also confusing because although they do have a limited asbestos survey for the renovation they filed as materials presumed. The complainant was concerned that the insulation they were dropping down a chute might be asbestos as well as that it was affecting the air and nearby properties. When (b) (6), and I arrived we observed a dumpster in the alley with a chute from an upper floor and a lot of insulation in and around the dumpster that had missed being captured. We issued the attached dust warning. Upon, receiving the warning they immediately took action and began cleaning the insulation from around the dumpster. I did not feel an NOV was warranted as it was unusual situation. They had employed a chute but it was ineffective in containing all the blown in insulation that was escaping their control method. Also, in speaking with the complainant they were very happy to see the remodel taking place and only wanted the situation remedied with the least amount of enforcement necessary.

blown insulation on ground
8/3/17

Regarding the debris & dust warning, I spoke with the crew and they will contain all insulation in closed bags before disposing them into the dumpster. I don't know if it was just carelessness or wind that caused the problem, but we'll take measures to prevent it in the future.
